Whitney Point Adaptive Management Plan

Flow Augmentation for Low Flow Events

**June 30, 2009
Water Quality Advisory
Committee Meeting**

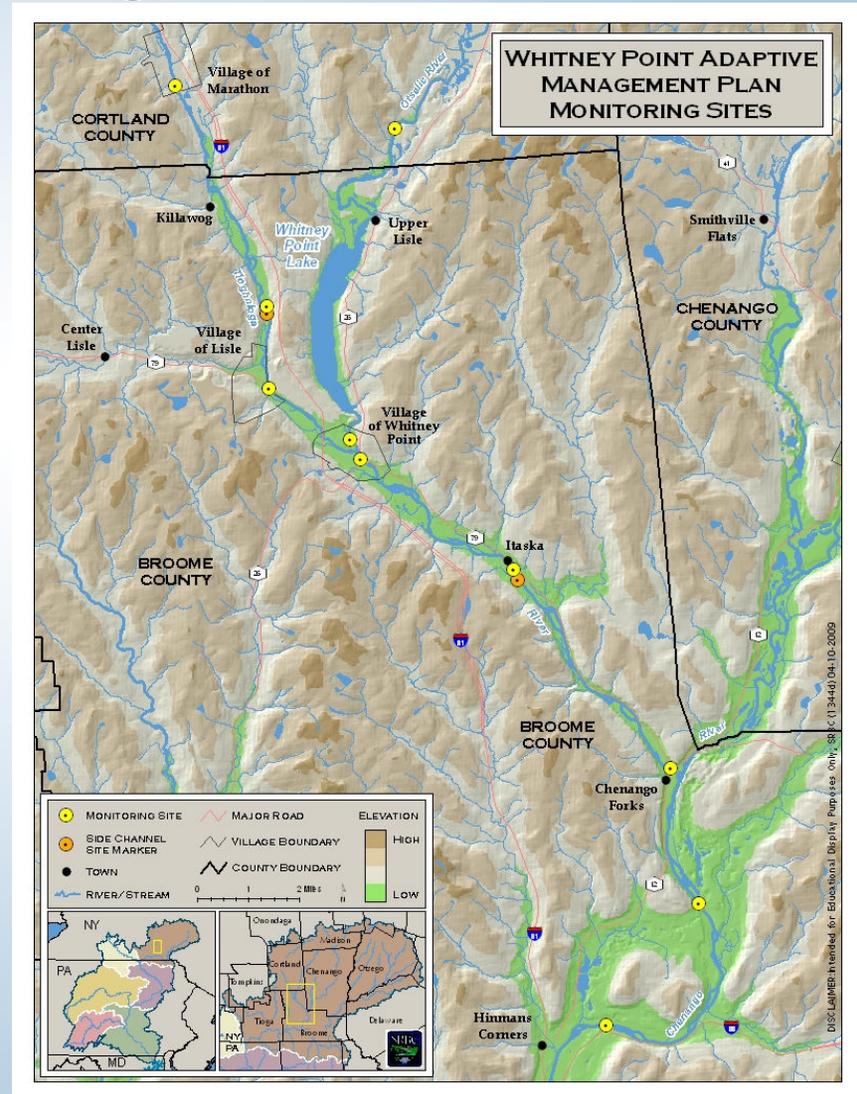
- Water quality was very good overall, with only a couple sites having slightly elevated nutrient levels.
- Macroinvertebrate communities were all rated as nonimpaired or slightly impaired except for the site directly downstream on the dam.
- Fish diversity was generally high, with good populations of game fish such as smallmouth bass, rock bass, and walleye.

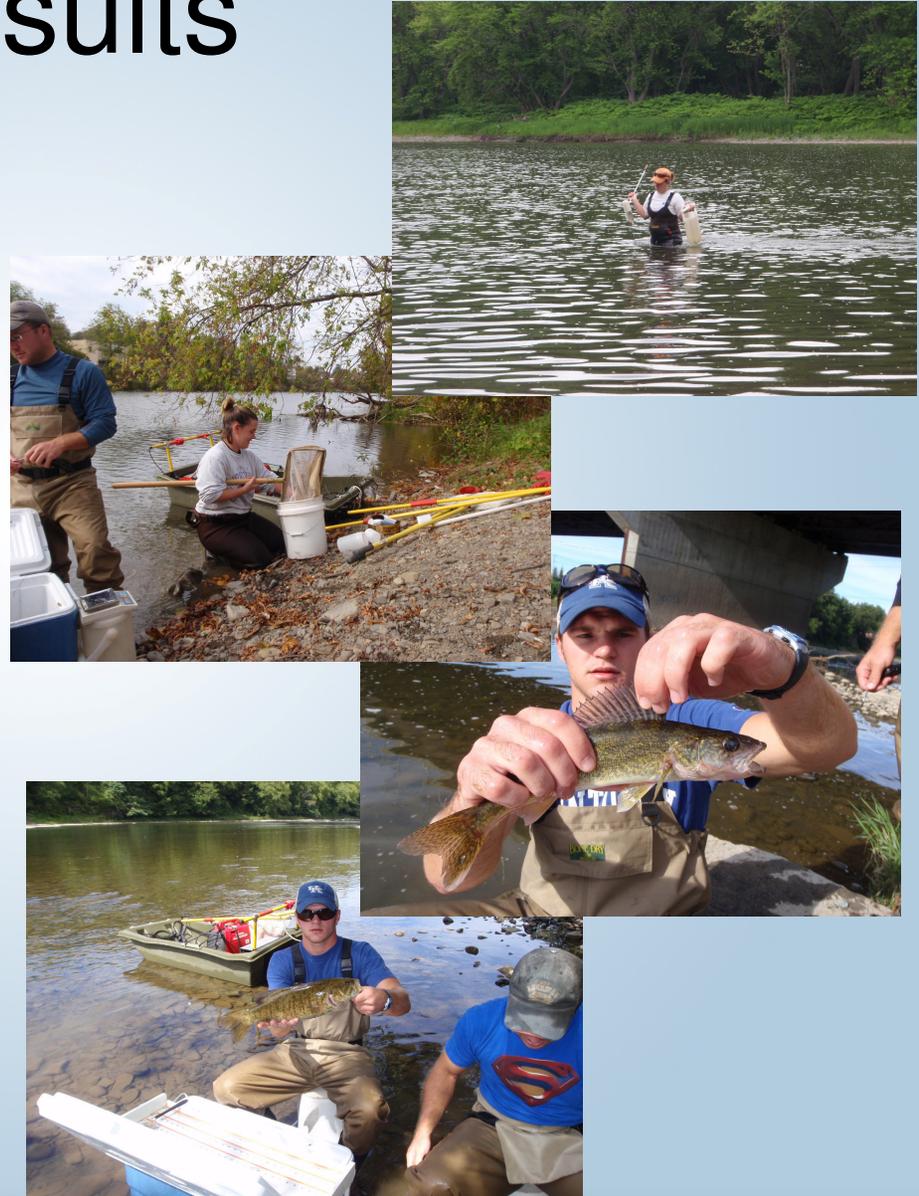
- The side channel areas provide excellent habitat for a variety of minnows and darters as well as young of the year smallmouth bass.
- As flows decreased in August and October, the loss of habitat in the side channels was very evident. (i.e., undercut banks and root wads were no longer under water, shallower pools, riffles were more exposed)
