Upper Half of the Middle Susquehanna Subbasin

Lower Half of the Middle Susquehanna Subbasin

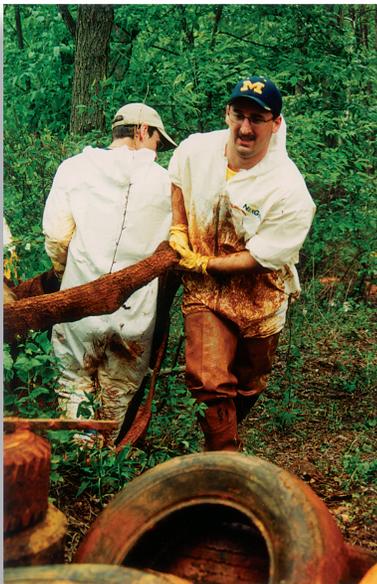
*Nescopeck Creek outfall severely impacted by acid mine drainage.
(Left) Robert Hughes of EPCAMR helps remove litter during Streamside Cleanup 2001.*
