Swatara Creek Watershed

East Conewago and West Conewago Creeks Watersheds

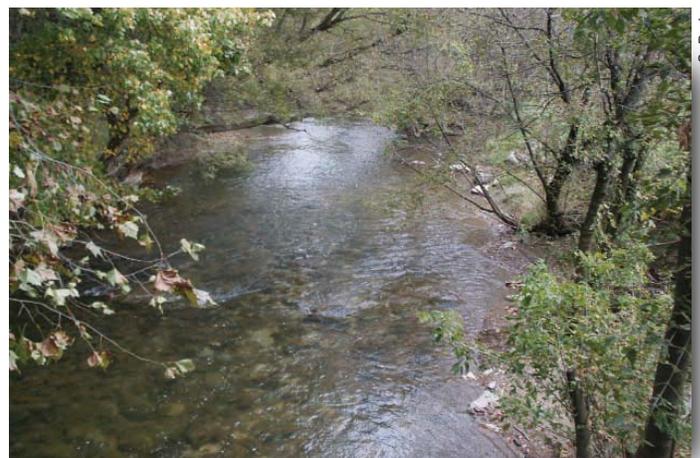
South Branch Codorus Creek.
